Manhole Inspection Summary

Manhole # S33I__010MH

Insp Date: **8/27/08 2:20 PM**

Location Address: **201 s howard st**

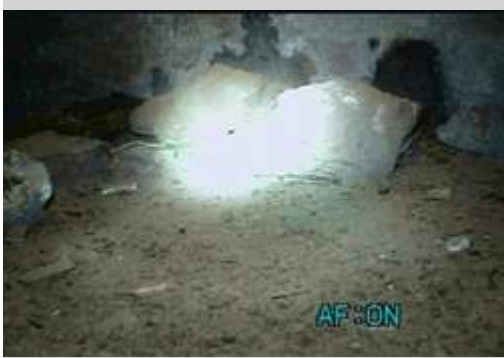
Defect 3

Condition: ☐ Sound ☐ Cracked ☐ Root Intrusion ☐ Deteriorated ☐ Leaks ☒ **Debris**

bench debris

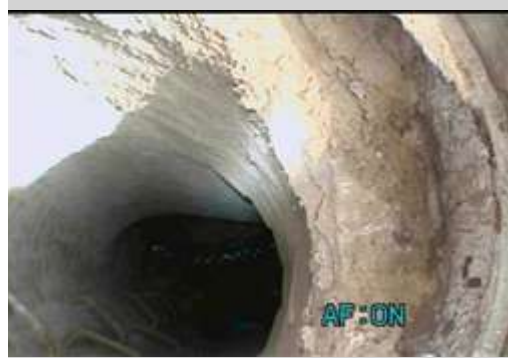
Defect 2

Frame Offset: **5** (in.) Condition: ☒ Sound ☐ Cracked ☐ Leaks

offset

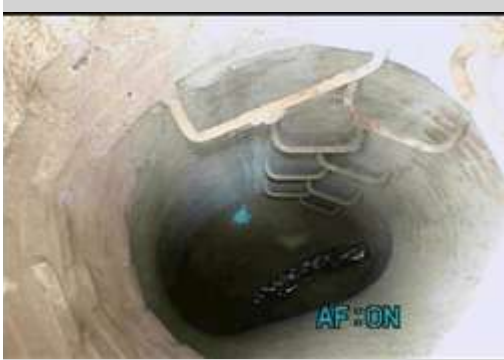
Defect 1

Steps Count: **9** Missing: **0** ☒ **Corroded**

steps

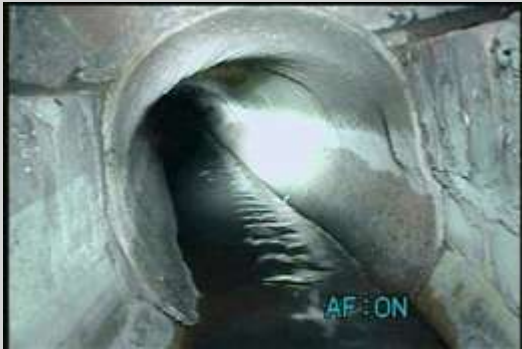
12 O'Clock Outflow

12 in. Circular Gravity Sewer
Pipe Out @ 12 O'Clock

Deposits: ☒ None ☐ Mud ☐ Sludge ☐ Debris ☐ Grease

Infiltration: **None** Pipe Seal Cond: **Unknown**

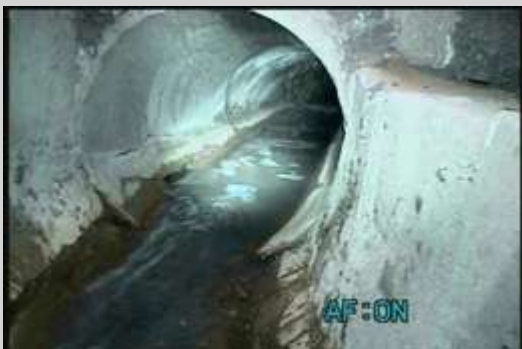
7 O'Clock Inflow

10 in. Circular Gravity Sewer
Pipe In @ 7 O'Clock

Deposits: ☒ None ☐ Mud ☐ Sludge ☐ Debris ☐ Grease

Infiltration: **None** Pipe Seal Cond: **Unknown**
